## STABILITY ANALYSIS OF THE BUTTAHATCHEE RIVER BASIN, MISSISSIPPI AND ALABAMA

USDA-ARS National Sedimentation Laboratory Report Number 50

**Mississippi Department of Environmental Quality**

**November 2005**

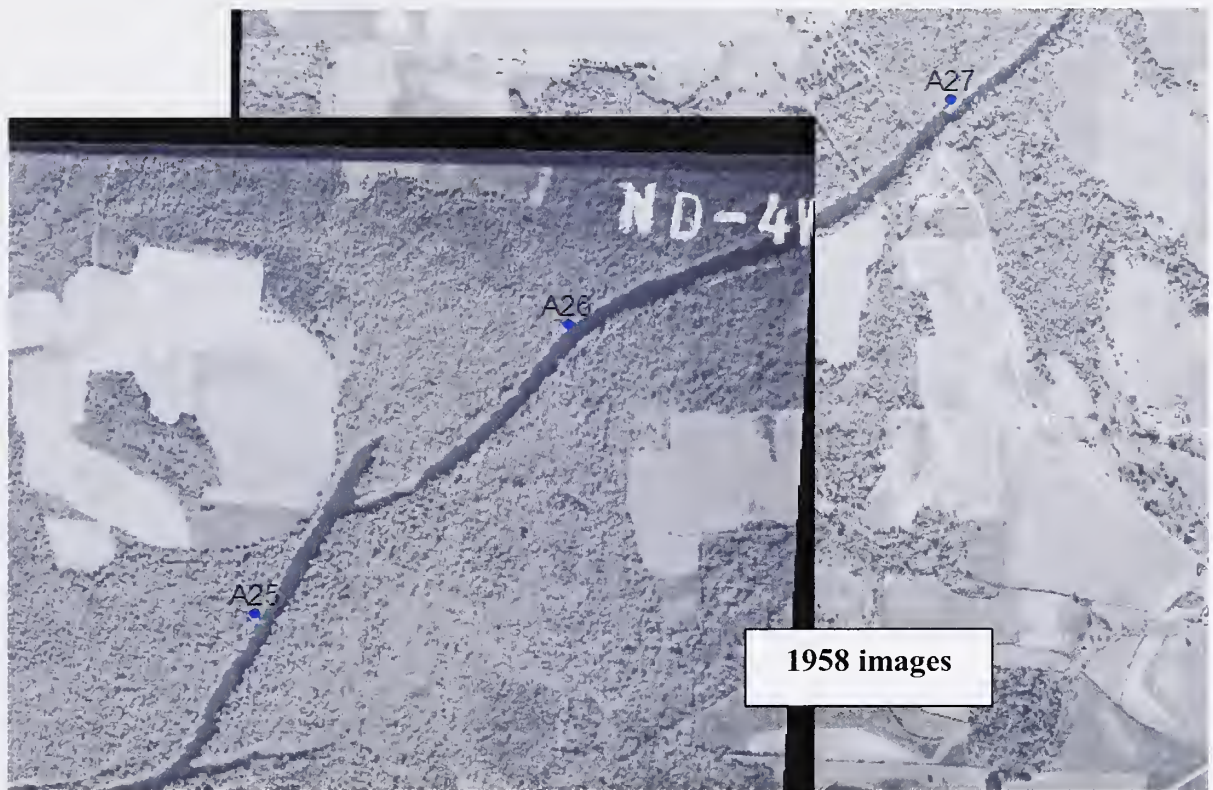
In addition, in the 1958 images, a section of reach A already appears to have been straightened (Figure 13).

**Figure 13 – Section of straightened channel (sites A24 to A27) in reach A in the 1958 images.**

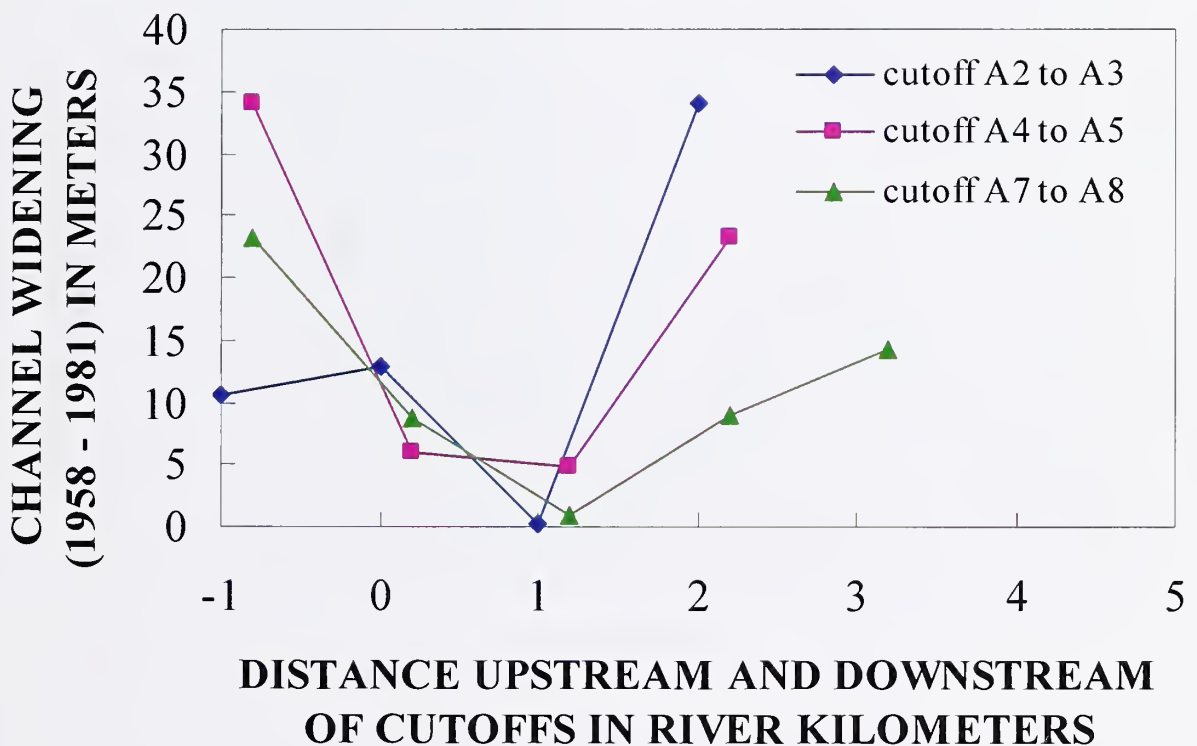
A shortening of channel length will increase channel slope by decreasing the channel length between two points. The result of increasing channel slope is an increase in flow energy, and the river's ability to transport sediment, assuming no other changes in sediment supply. An increase in flow energy must then be dissipated in some way through changes in channel planform and geometry including incision and/or channel widening. In contrast a reduction in channel slope tends to lead to deposition and aggradation as less energy is available to transport sediment. Changes in width accompanied the meander cutoffs in the A reach, with widening generally occurring both upstream and downstream of the cutoffs. Maximum widening occurred 2-3 rkm's upstream of the cutoffs and approximately 1rkm downstream of the cutoffs (Figure 14)

Figure 14 – Channel widening up- and downstream of the three cutoffs that occurred between the 1958 and 1981 air photos.

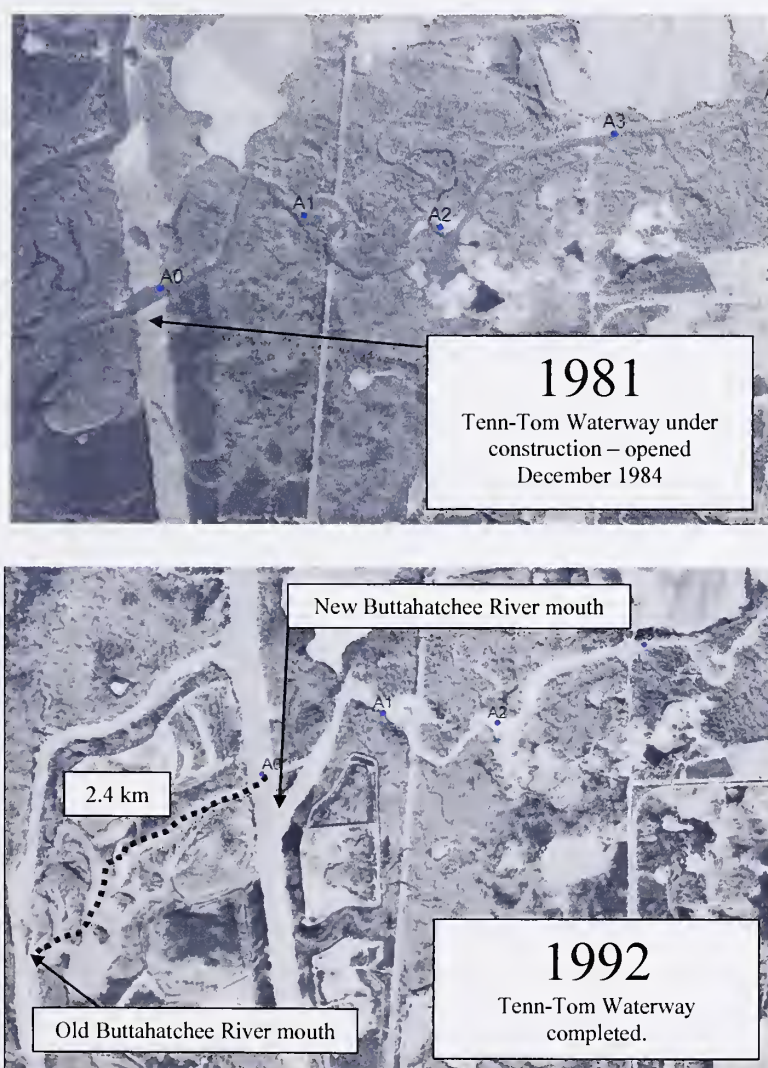
1. In the 1981 image, the construction of the Tennessee-Tombigbee Waterway (TTW) can be seen to be underway; the waterway opened in December 1984. Construction of the waterway relocated the mouth of the Buttahatchee River, cutting off 2.4 km from the lower end of the Buttahatchee River (Figure 17). The normal pool elevation in the Columbus pool is 163 f.a.s.l, and this level effectively raised the base level of the Buttahatchee River. The impoundment of the Columbus pool affects the Buttahatchee River up to about 1km upstream of its mouth (Jones, 1991). The raising of a channel's base level has the effect of causing aggradation in the lower reaches, by reducing water surface slope, flow velocities, and the energy available to transport sediment. Bank widening can also be associated with aggradation.

**Figure 17 – Air photos showing location of the mouth of the Buttahatchee River pre- and post-Tennessee-Tombigbee Waterway construction.**

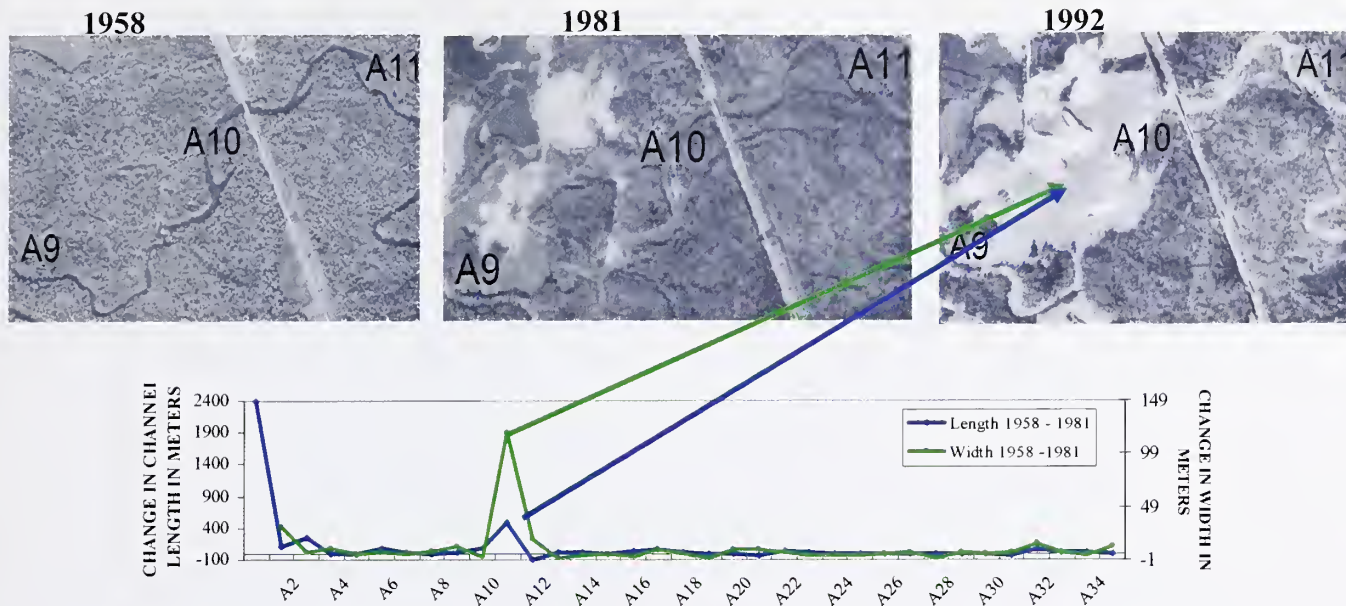
2. Floodplain gravel-mining operations in reach A of the Buttahatchee River intensified in the late 1970’s and early 1980’s, with a series of gravel mines being situated just to the south of the HWY45 bridge near site A10. The geology and topography of the floodplains of the east-bank tributaries to the TTW (which includes the Buttahatchee River), contribute to the ability of the east-bank tributaries to supply significant bed material load to the TTW. Conversely the west-bank tributaries to the TTW tend to supply more of the suspended sediment load as they flow through finer grained materials. Simons *et al* (1982) encouraged gravel extraction in tributary source areas because their sediment transport analysis showed that the permanent rise in water surface at low and intermediate stages in the Columbus Pool, and subsequent increase in the Buttahatchee River base level would cause aggradation in the floodplain reaches of the Buttahatchee River throughout much of the year, thereby reducing the quantity of sediment delivered to the pool. Gravel mining in the tributary source areas would thus improve the hydraulic efficiency of the tributary reach (in this case the Buttahatchee River), and reduce problems associated with aggradation in the floodplain reaches of the tributaries, while also enhancing the delivery of coarse materials to the main stem of the TTW (Simons *et al*, 1982). The Simons *et al* report (1982) does warn however that over-exploitation of the tributary reaches could produce instability and bankline failure. Air-photo analysis shows that the river channel throughout the heavily mined section has captured abandoned and active gravel mines. In addition, during the winter floods of 1989, a berm separating the river from an active gravel mine just west of HWY45 was breached and a large quantity of loose gravel was transported downstream (Jones, 1991). The resulting capture of the gravel mines has significantly altered the channel’s course through this section (Figure 18).

**Figure 18 – Air photo images from 1958, 1981 and 1992, showing the gravel mine capture and resulting capture and shortening of the course of the river at this location.**

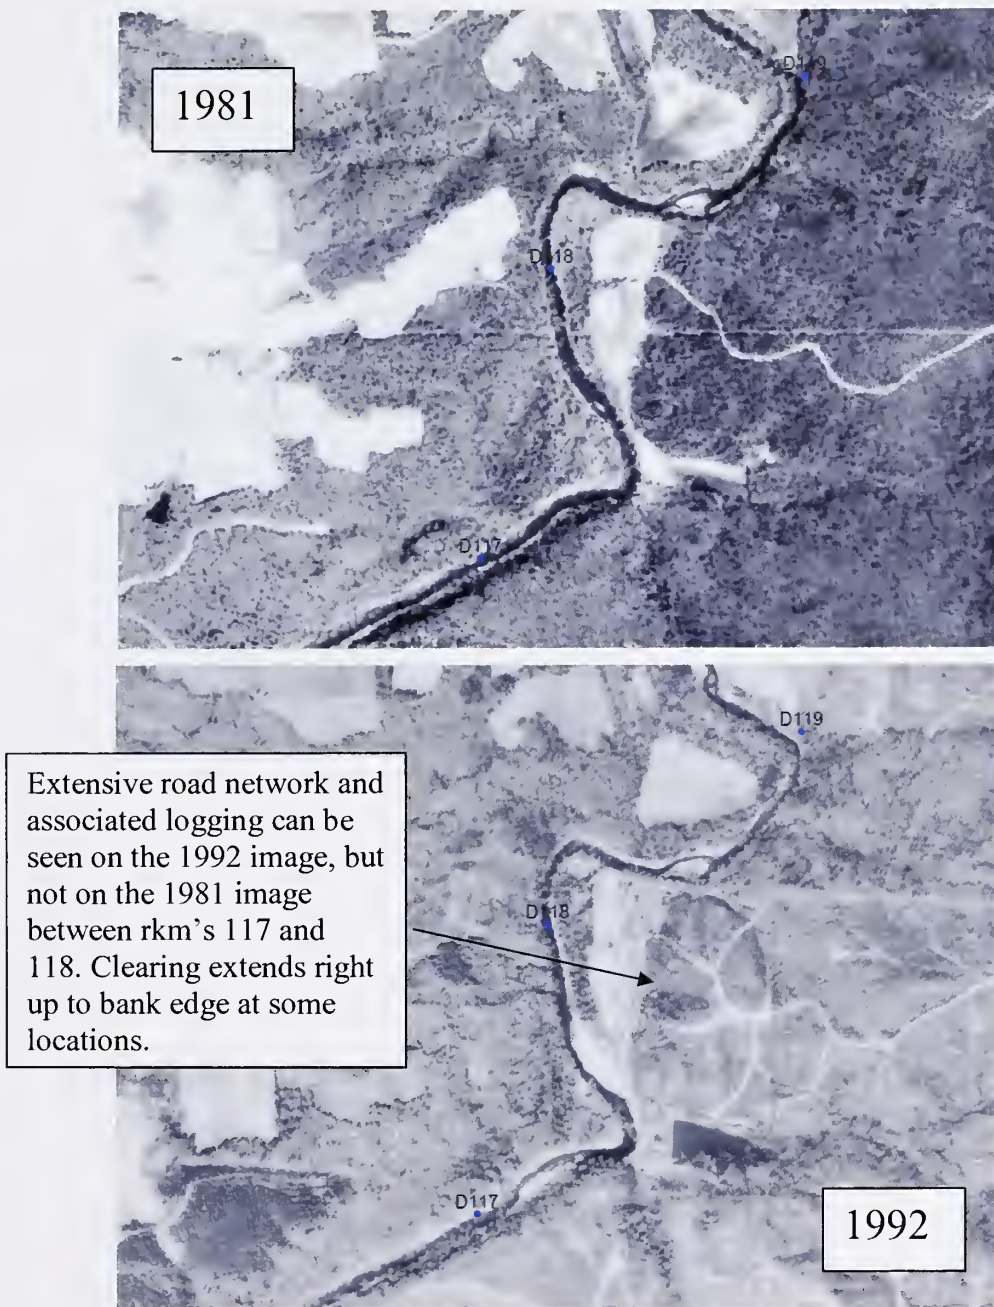
The average widening rate in reach D was at its highest during the period 1981-1992 (Figures 19 and 27). Analysis of the air photography shows that sometime between the 1981 and 1992 images, a large area of land was logged on the east bank of the river between rkm's 117 and 118. The area of logging extended right up to the bank edge, and was accompanied by a grade control structure and check dam. Other areas of land clearance are also visible in this reach on the aerial photography (Figure 20).

**Figure 20 - Air photography from 1981 and 1992 for rkm's 117 to 118, showing logging and land clearance on east bank of the Buttahatchee River.**

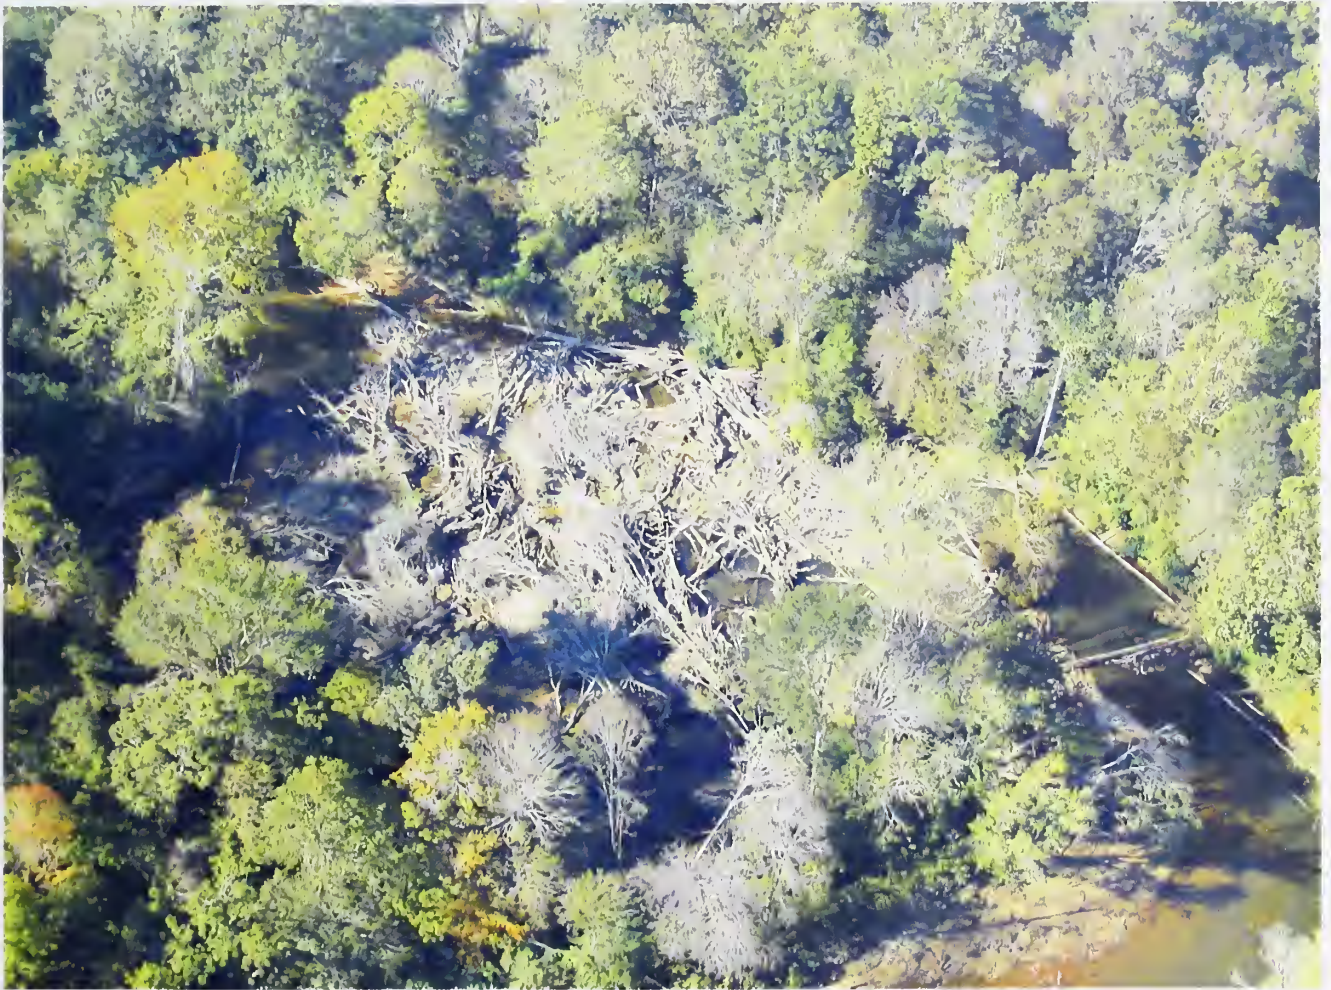
**Figure 45 – Log jam in the Buttahatchee River at rkm D98, estimated at 100-200 m in length.**

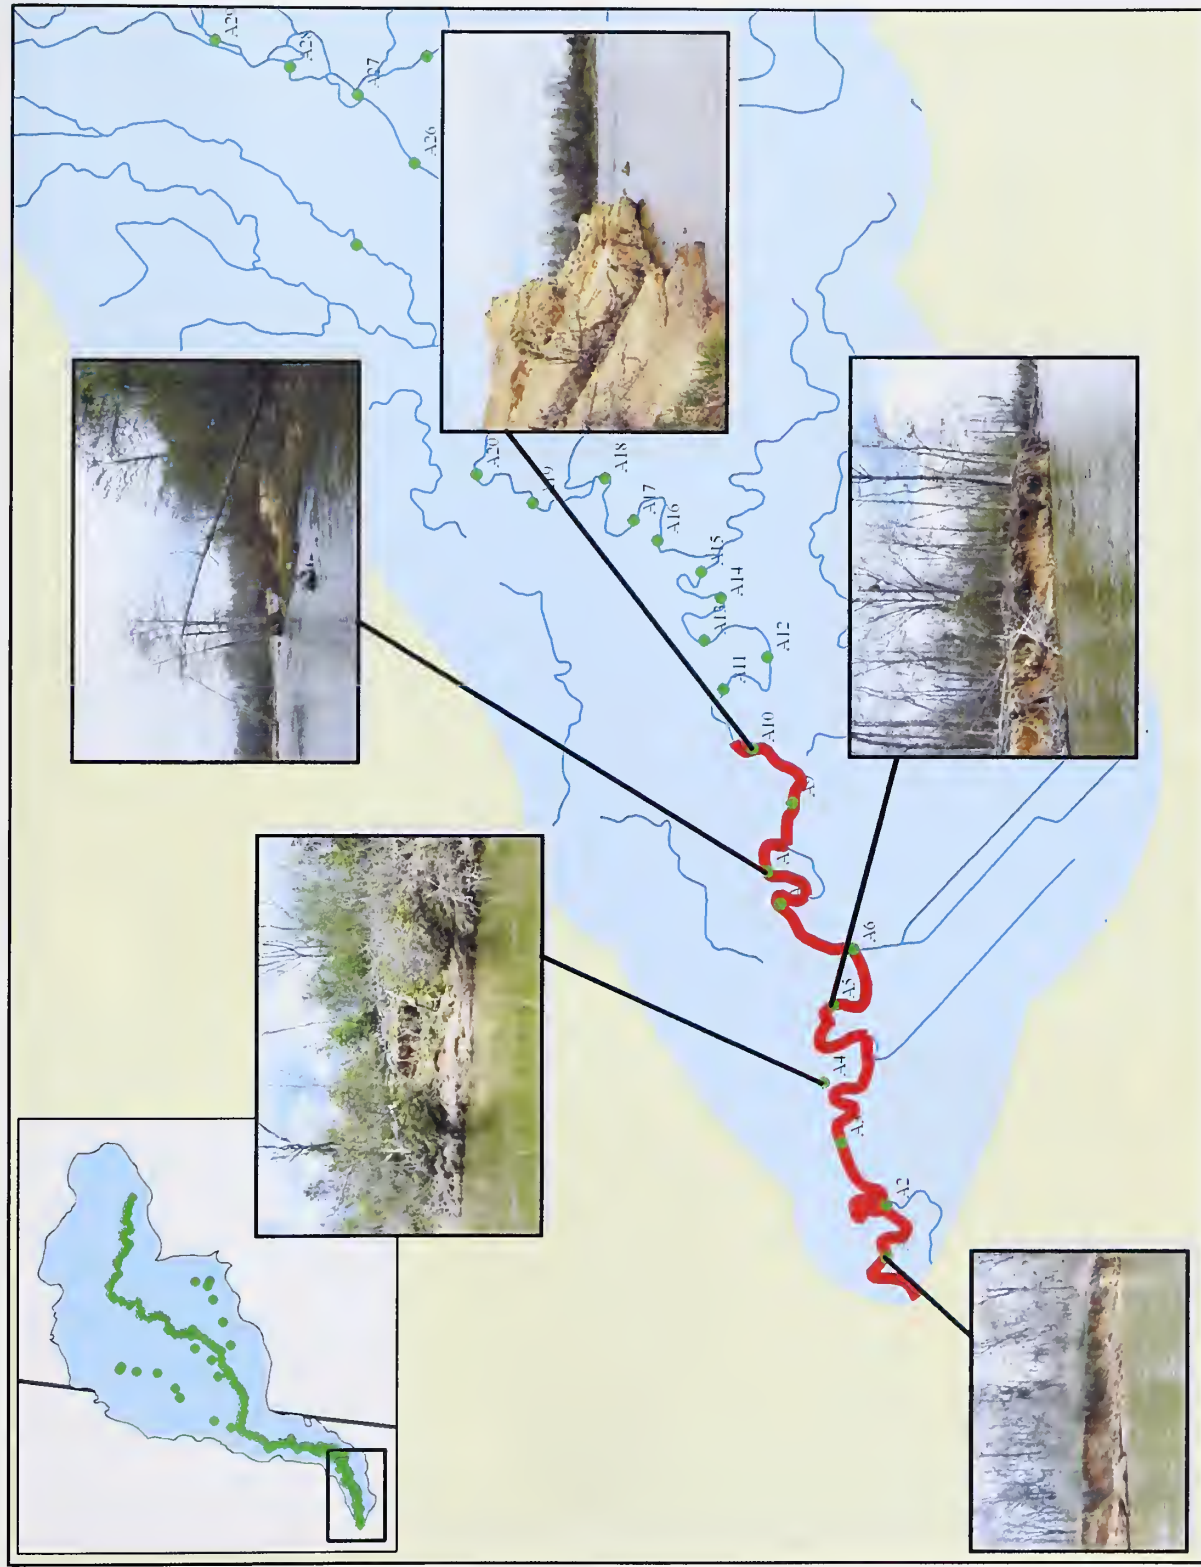
Figure 57 – Problem areas on the Buttahatchee River between rkm's A0 and A10.

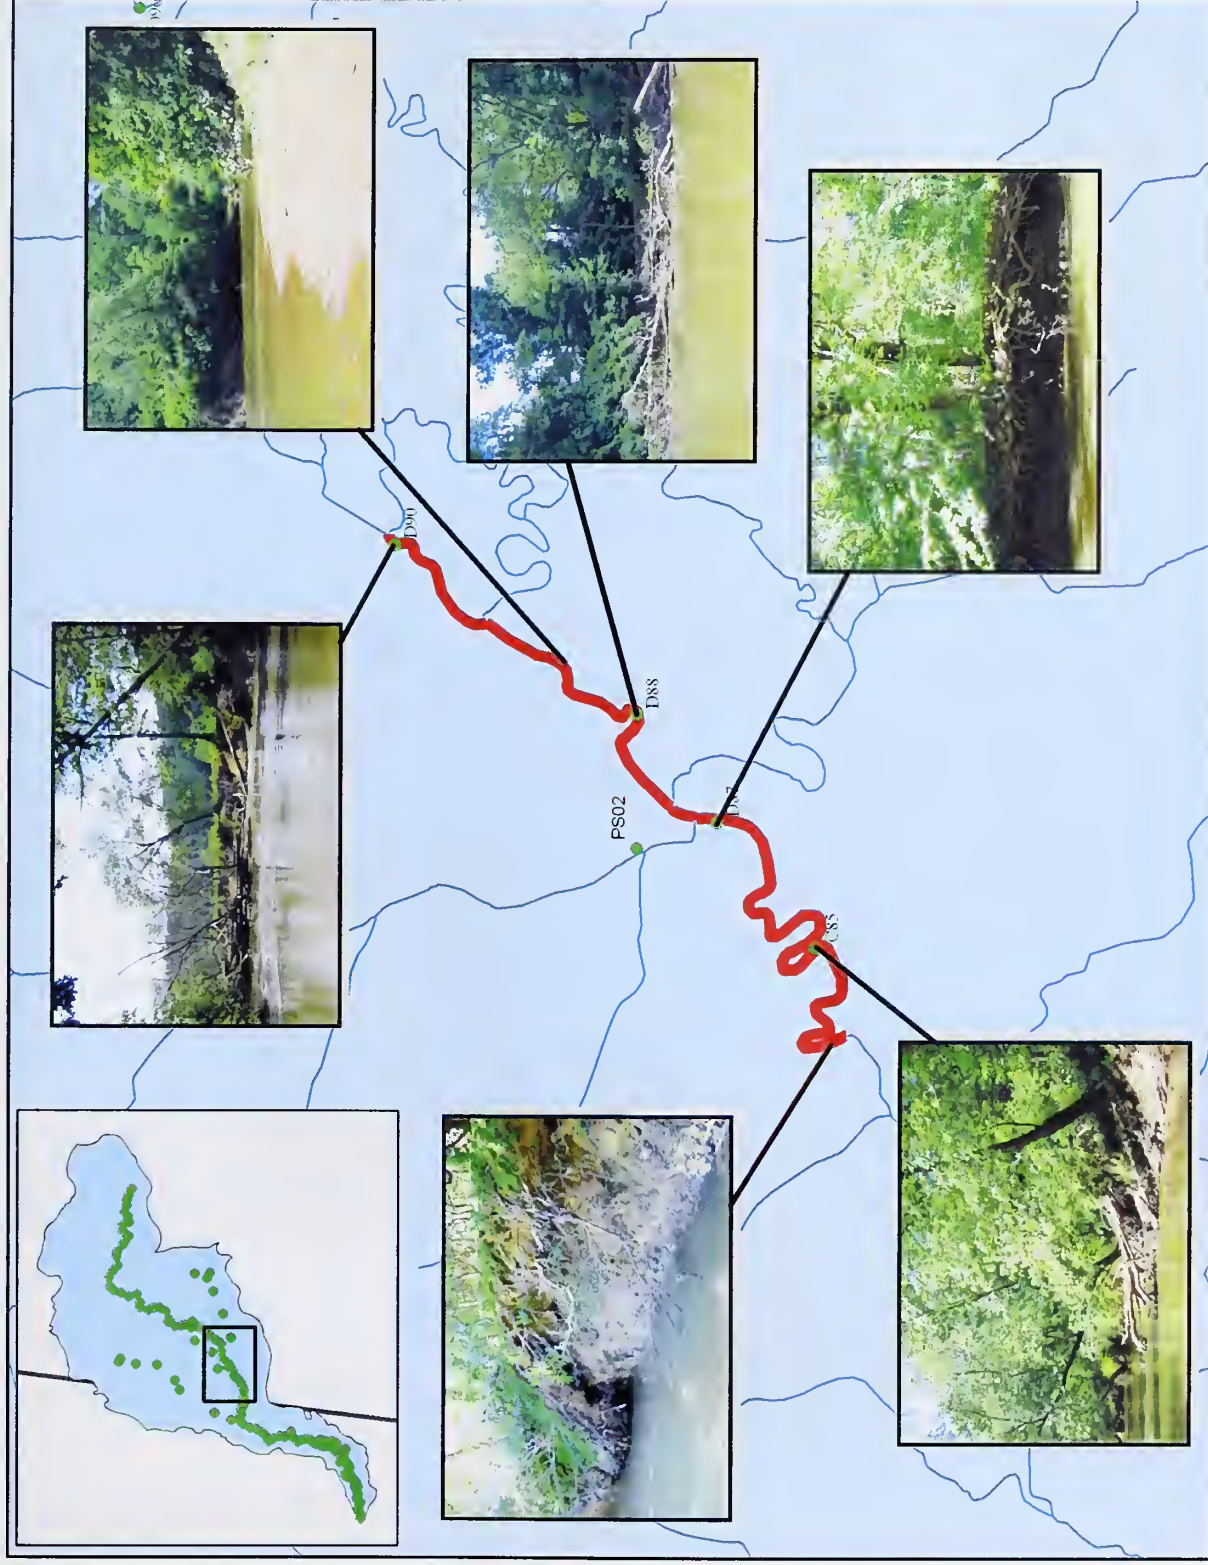
Figure 58 – Problem areas on the Buttahatchee River between rkm’s C84 and D90.

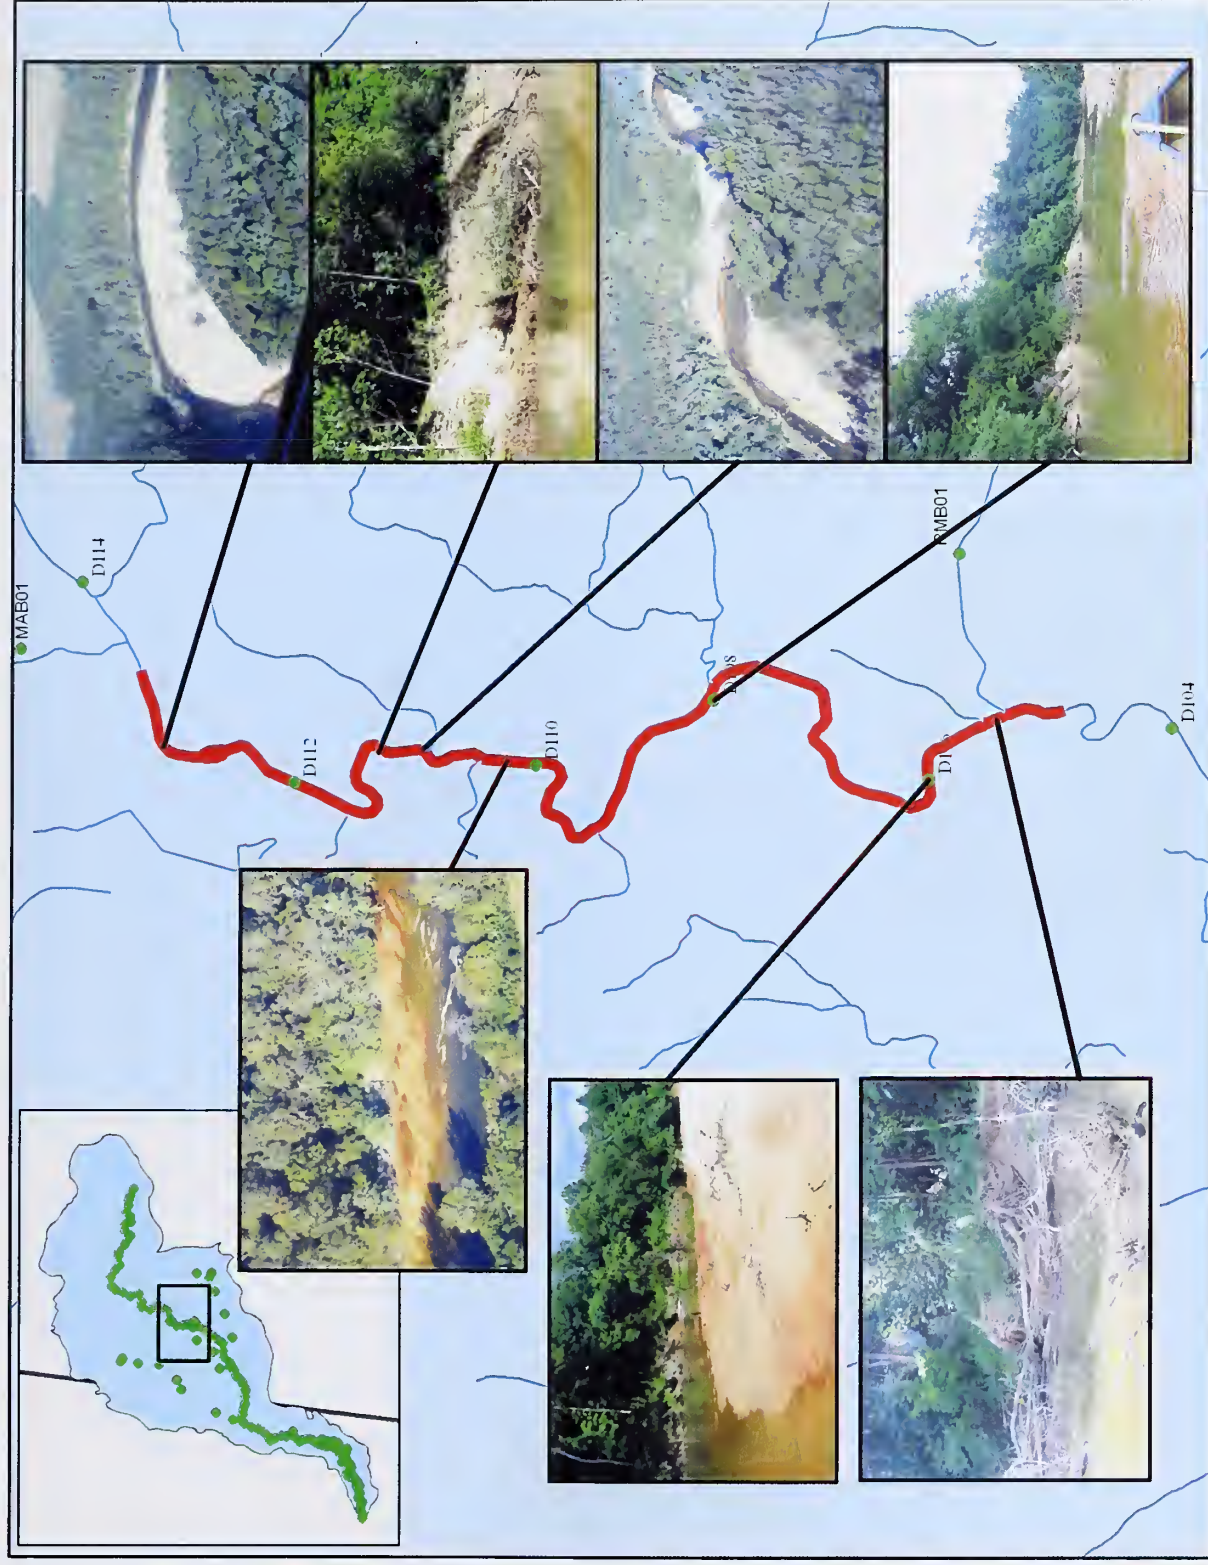
Figure 59 – Problem areas on the Buttahatchee River between rkm's D105 and D113.

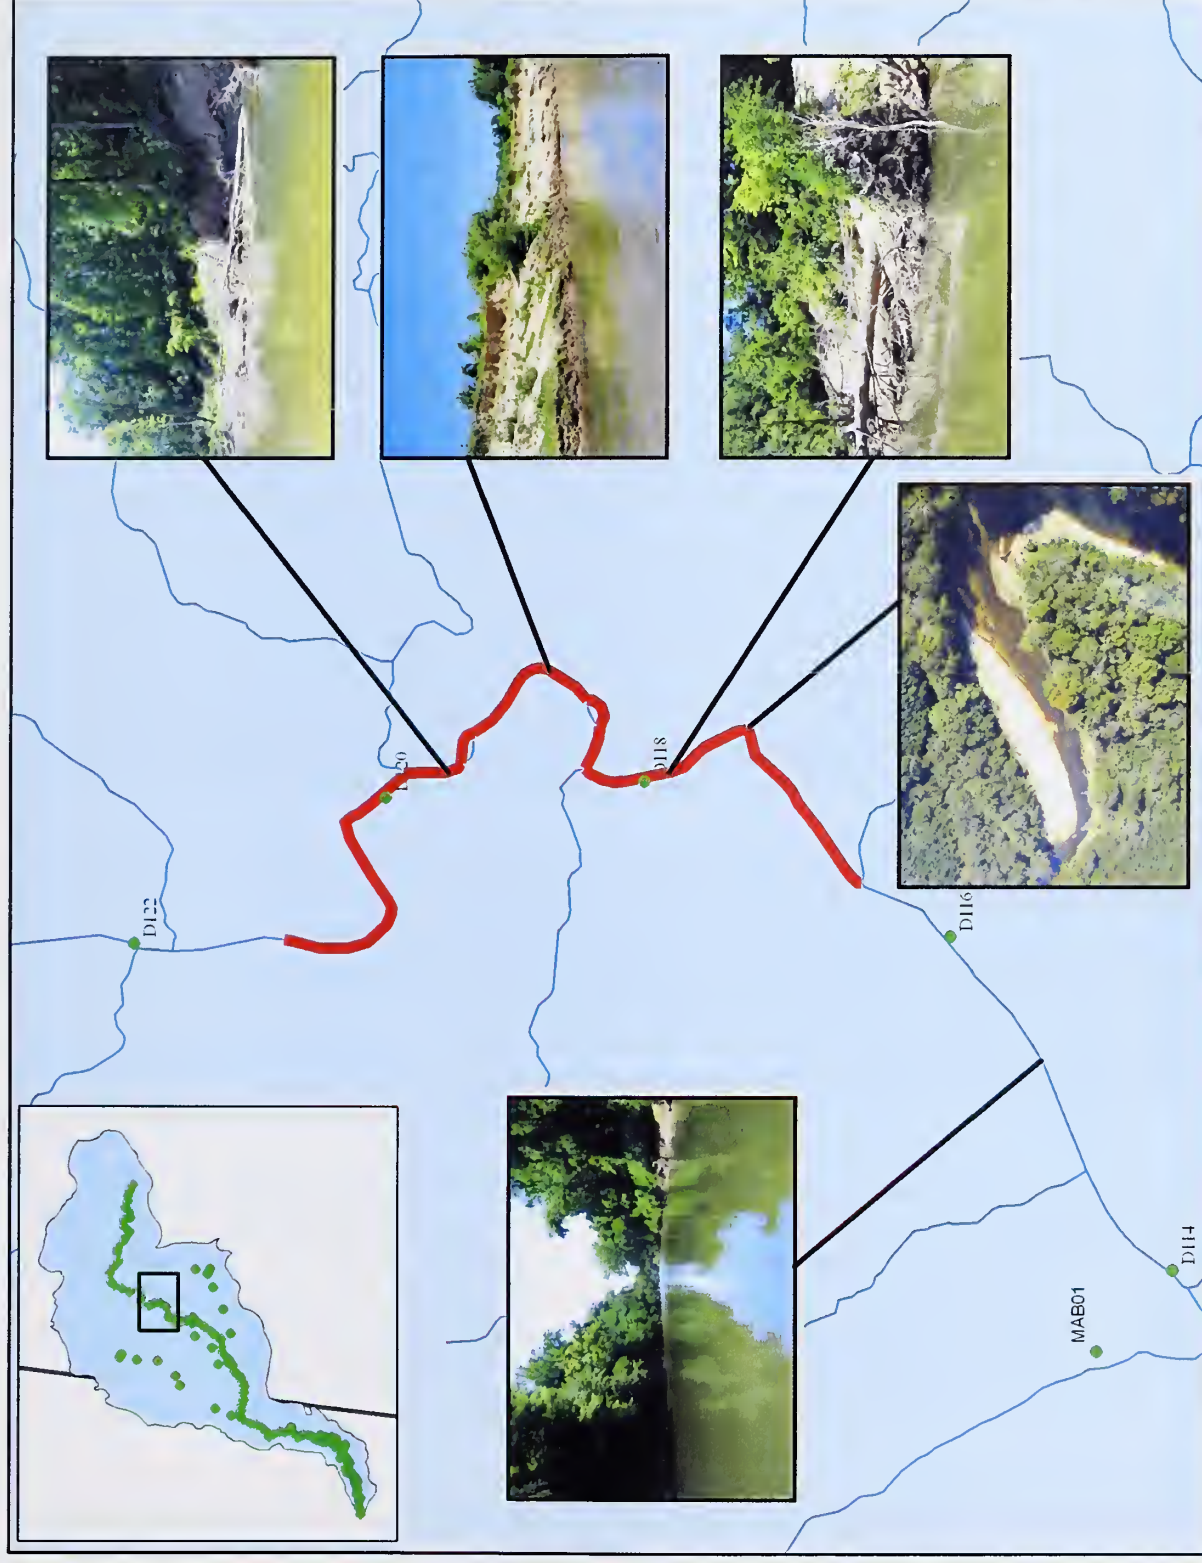
Figure 60 – Problem areas on the Buttahatchee River between rkm’s D117 and D121.
